Dread in Wetland Bed

Corporations, Government, and All Their
Peatland Restoration Empty Commitments.

2024

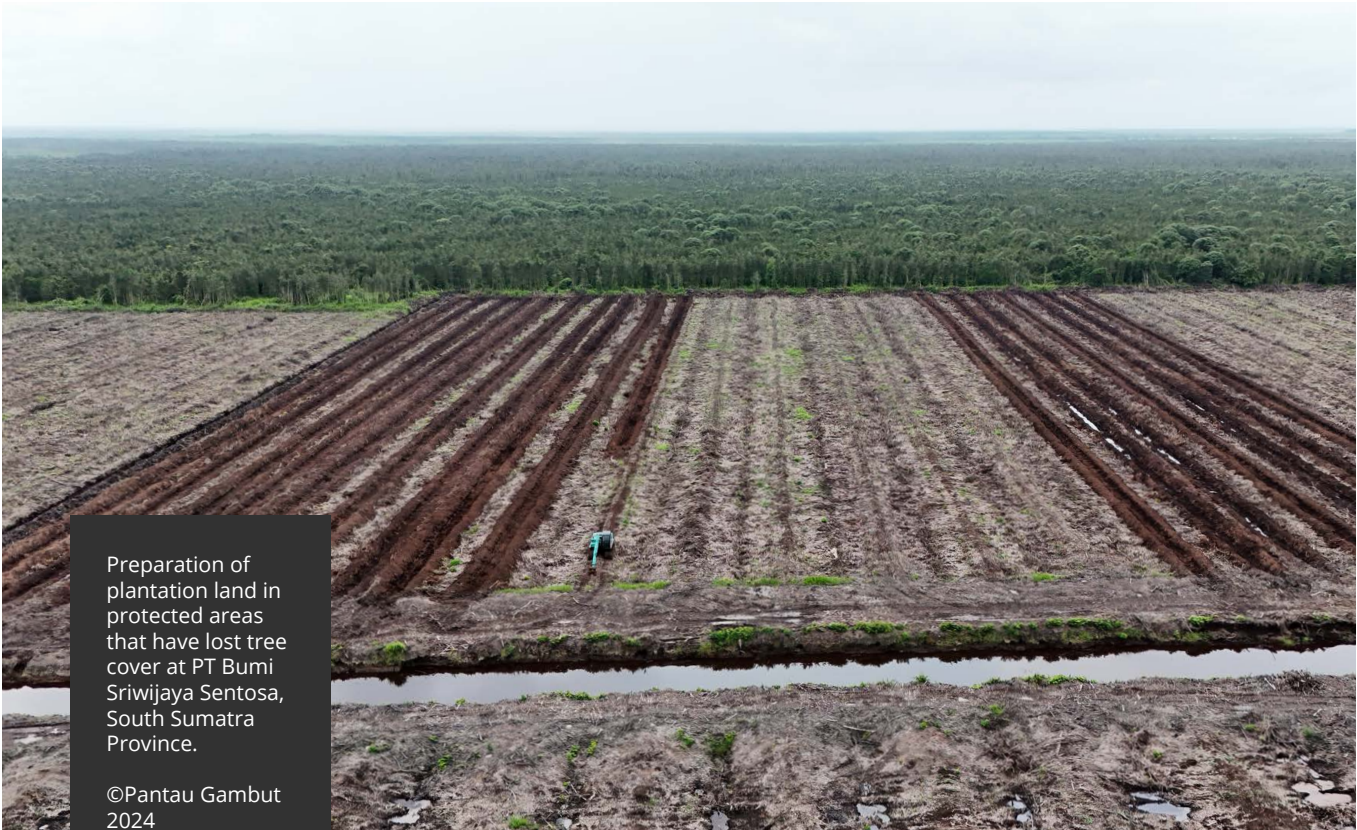
Preparation of plantation land in protected areas that have lost tree cover at PT Bumi Sriwijaya Sentosa, South Sumatra Province.

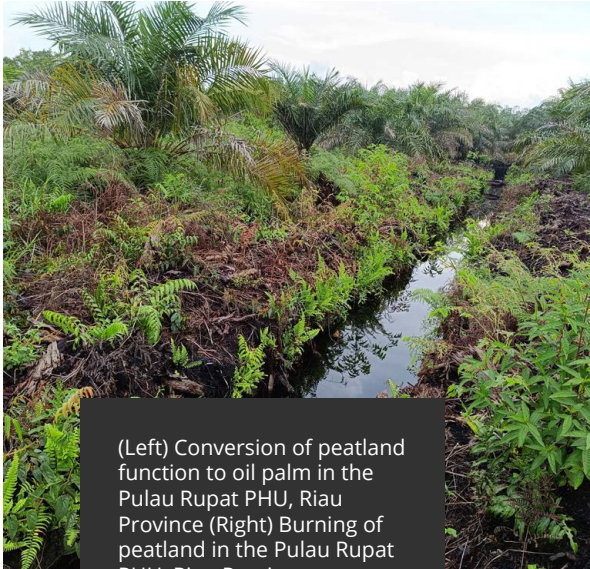
(Left) Conversion of peatland function to oil palm in the Pulau Rupert PHU, Riau Province (Right) Burning of peatland in the Pulau Rupert PHU, Riau Province.

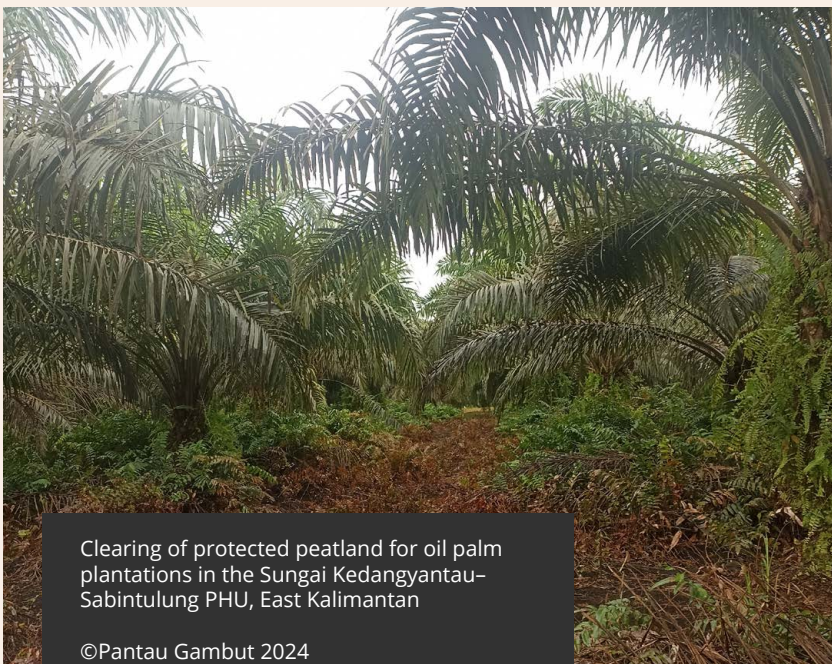
Clearing of protected peatland for oil palm plantations in the Sungai Kedangyantau–Sabintulung PHU, East Kalimantan

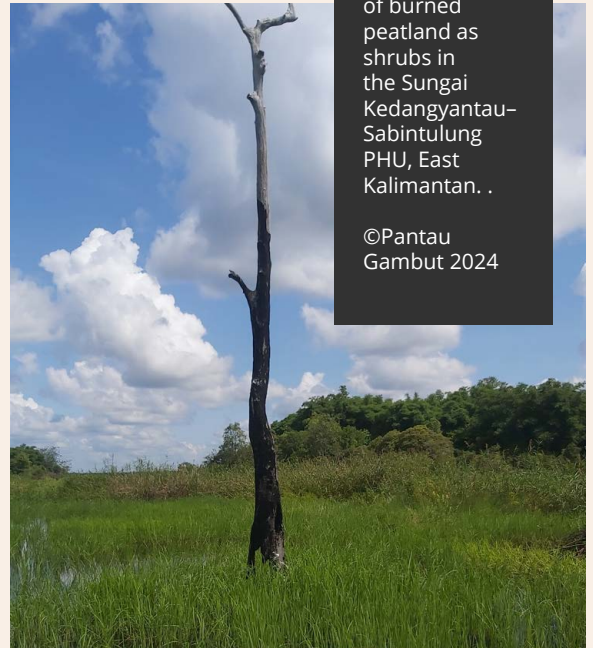
Abandonment of burned peatland as shrubs in the Sungai Kedangyantau-Sabintulung PHU, East Kalimantan. .

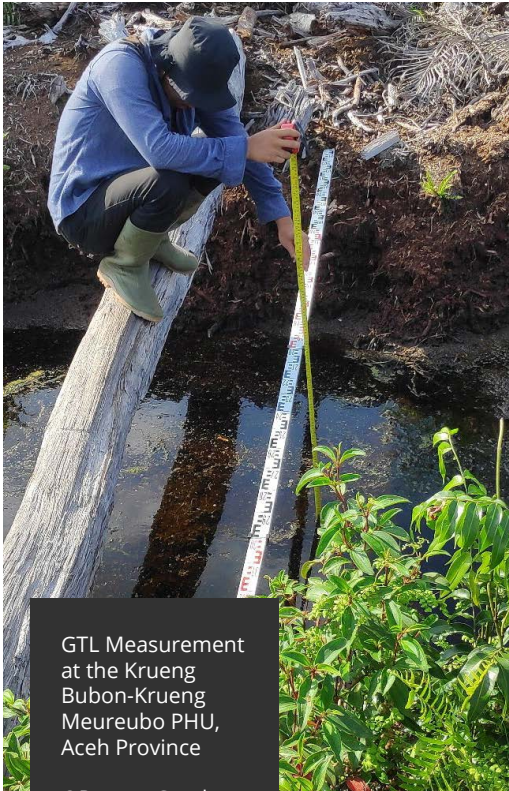
GTL Measurement at the Krueng Bubon-Krueng Meureubo PHU, Aceh Province
©Pantau Gambut 2024

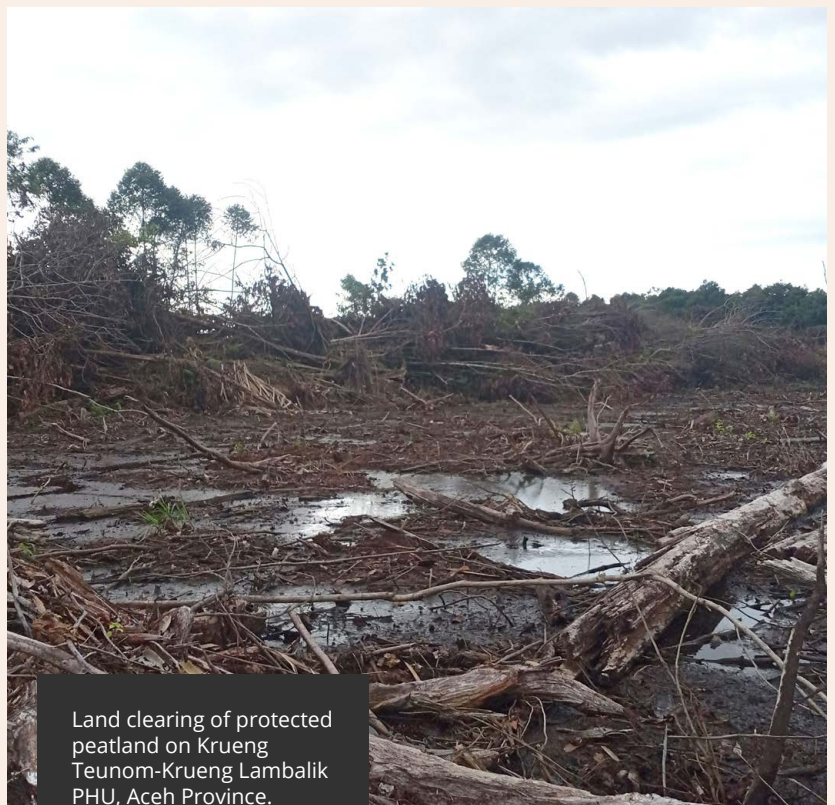
Land clearing of protected peatland on Krueng Teunom-Krueng Lambalik PHU, Aceh Province.

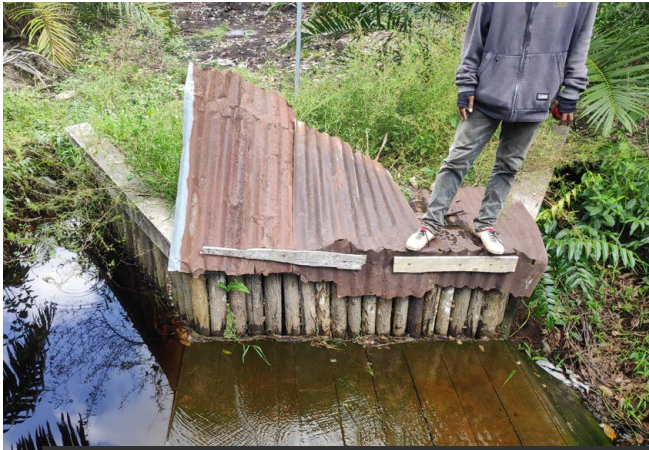
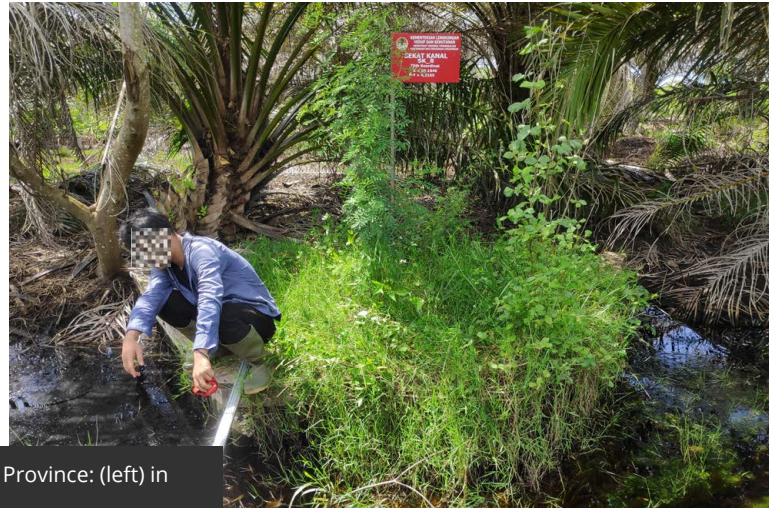
Canal blocks in Krueng Bubon–Krueng Meureubo PHU, Aceh Province: (left) in good condition and (right) overgrown with shrubs.

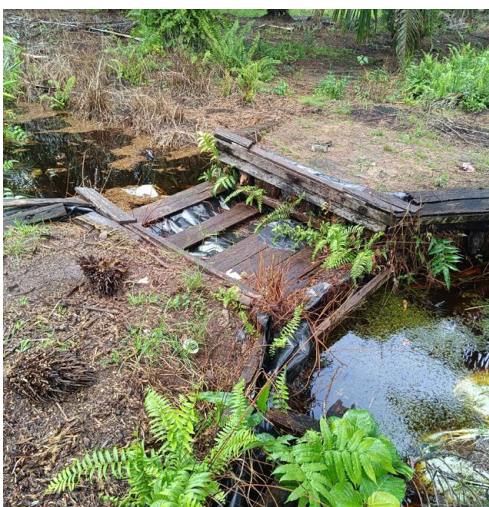
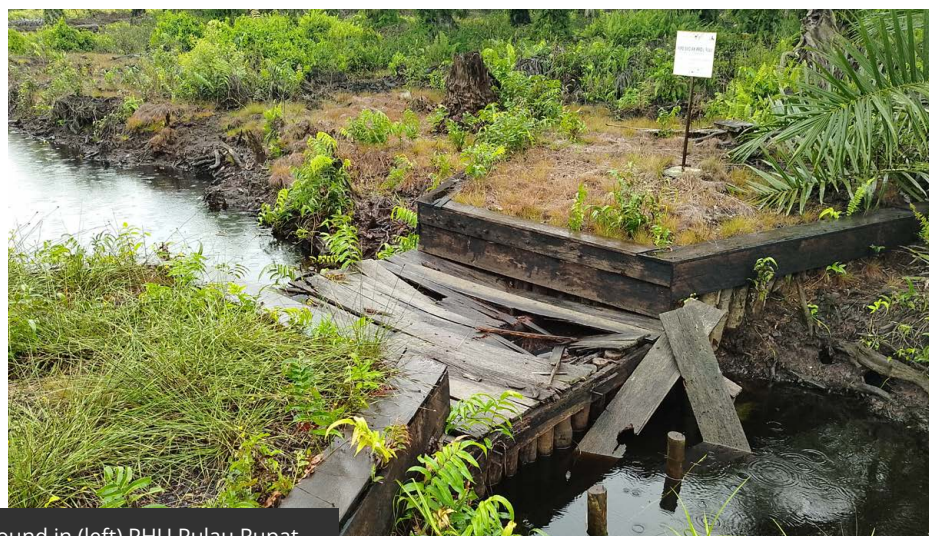
Unfortunately, as one of the priority areas for peatland restoration, 70% of the 77 canal blocks found were damaged. This indicates that the canal blocks already constructed are neither

monitored nor maintained by the government to ensure they remain in good condition. Additionally, some of the damage is due to deliberate vandalism.

BRGM canal blocks in damaged condition found in (left) PHU Pulau Rupal and (right) Sungai Rokan–Sungai Siak Kecil PHU, Riau Province.

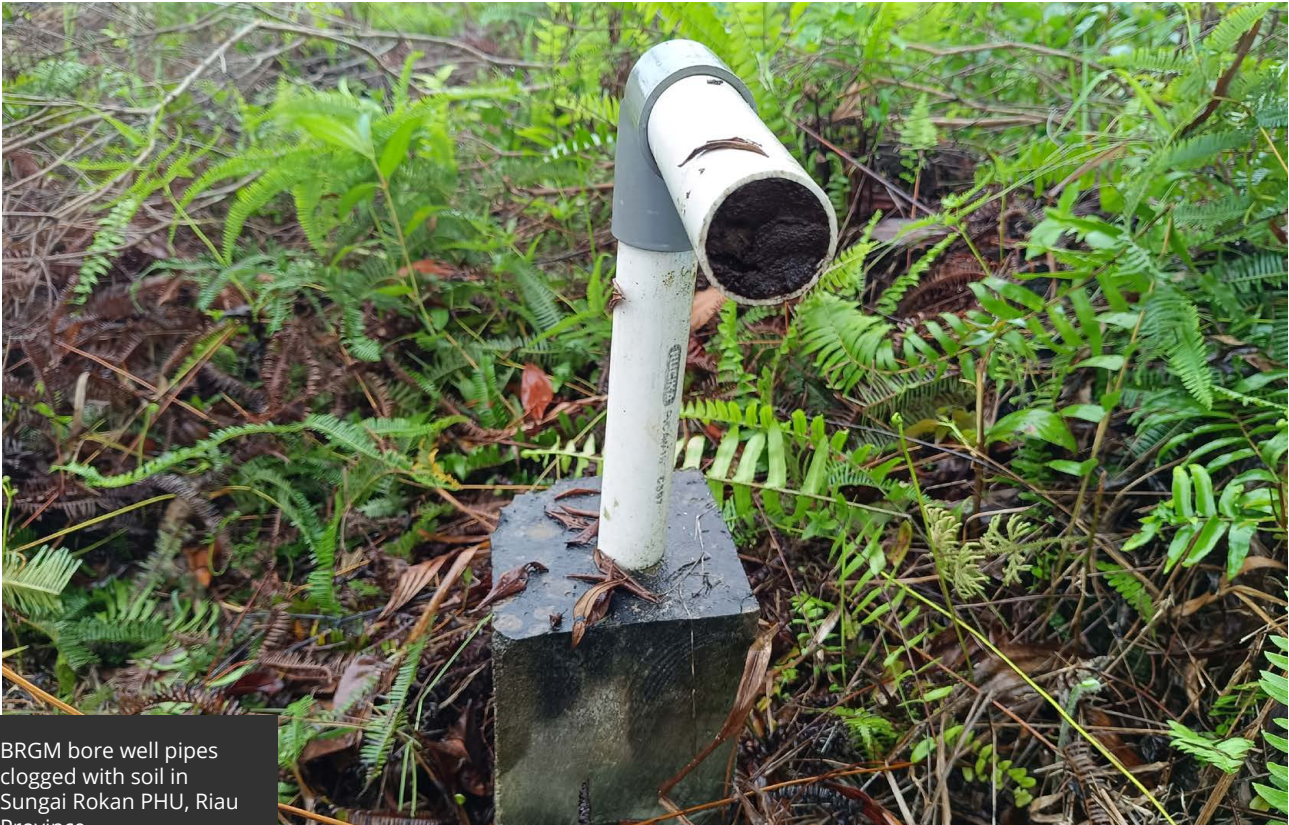
BRGM bore well pipes clogged with soil in Sungai Rokan PHU, Riau Province.

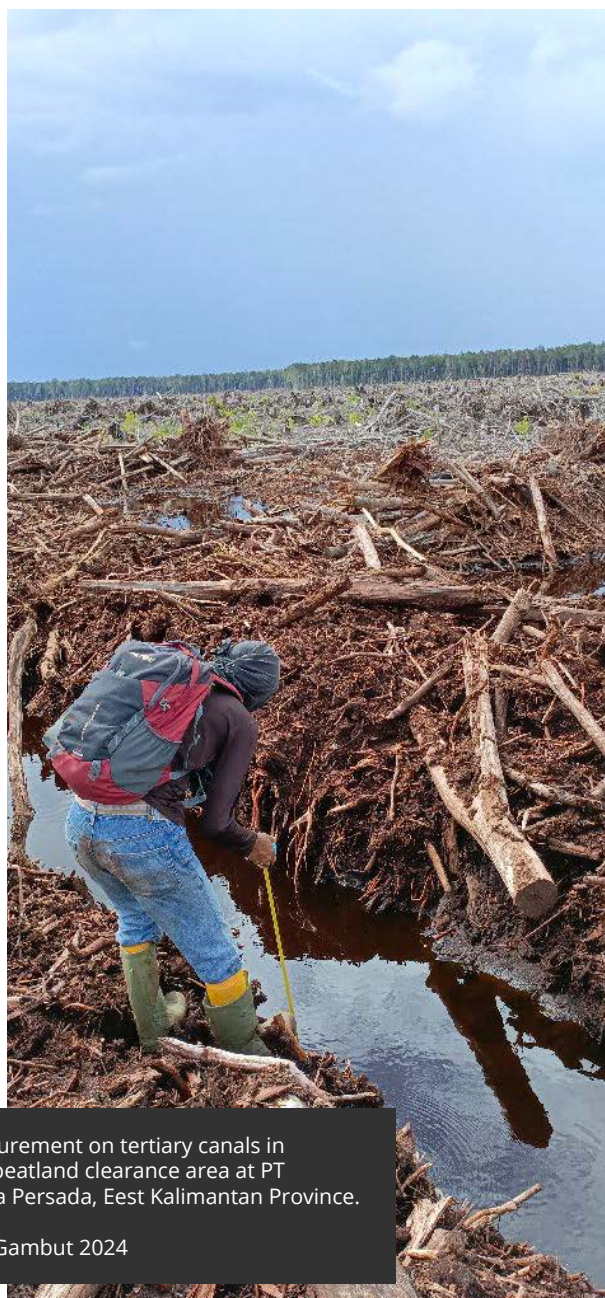
GTL measurement on tertiary canals in a former peatland clearance area at PT Mayawana Persada, East Kalimantan Province.

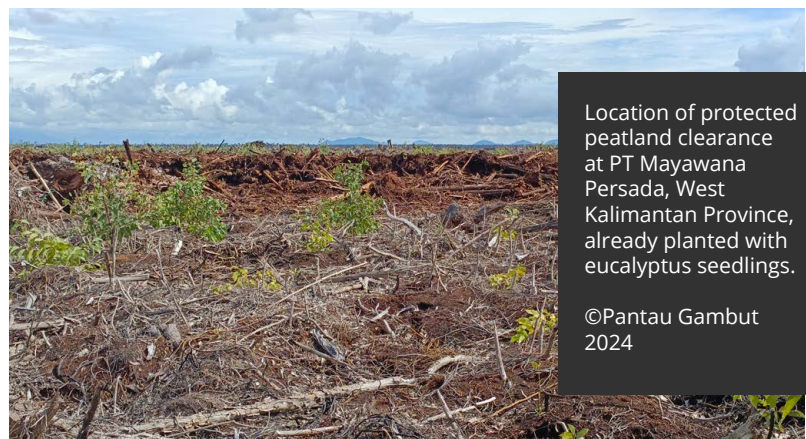
Location of protected peatland clearance at PT Mayawana Persada, West Kalimantan Province, already planted with eucalyptus seedlings.

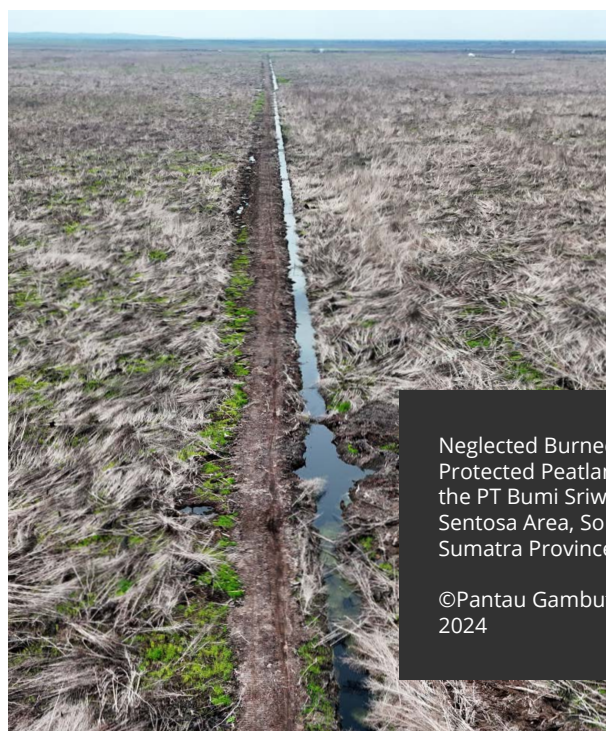
Neglected Burned Protected Peatland in the PT Bumi Sriwijaya Sentosa Area, South Sumatra Province.

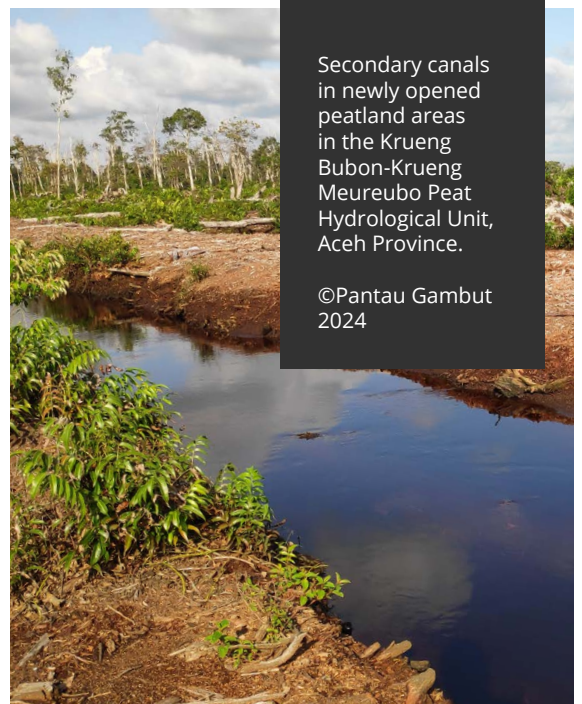
Secondary canals in newly opened peatland areas in the Krueng Bubon-Krueng Meureubo Peat Hydrological Unit, Aceh Province.

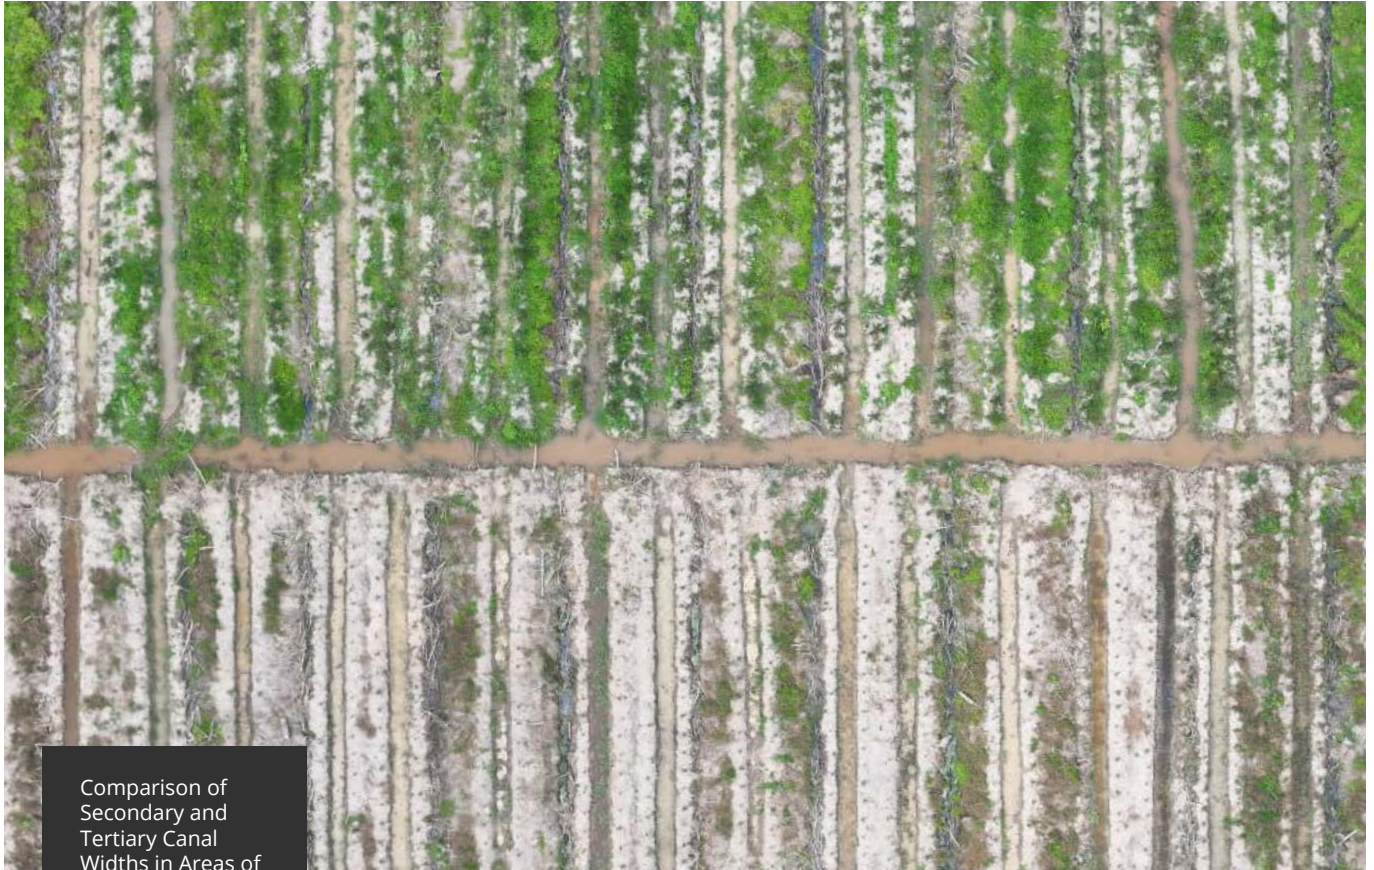
Comparison of Secondary and Tertiary Canal Widths in Areas of PT Bumi Sriwijaya Sentosa, South Sumatra Province, Experiencing Deforestation

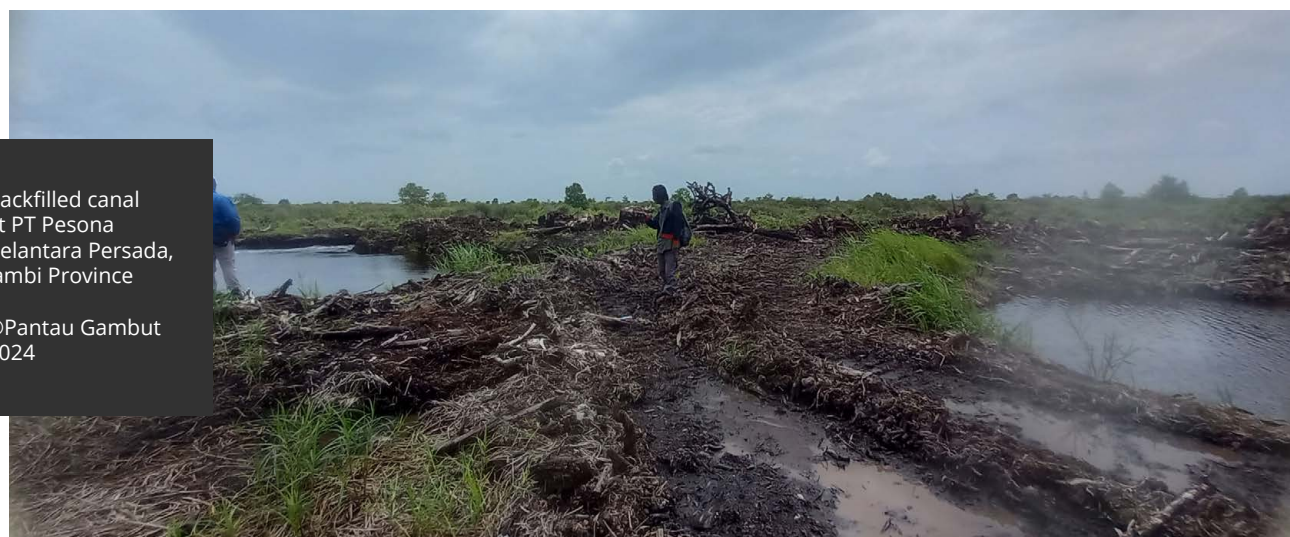
Backfilled canal at PT Pesona Belantara Persada, Jambi Province

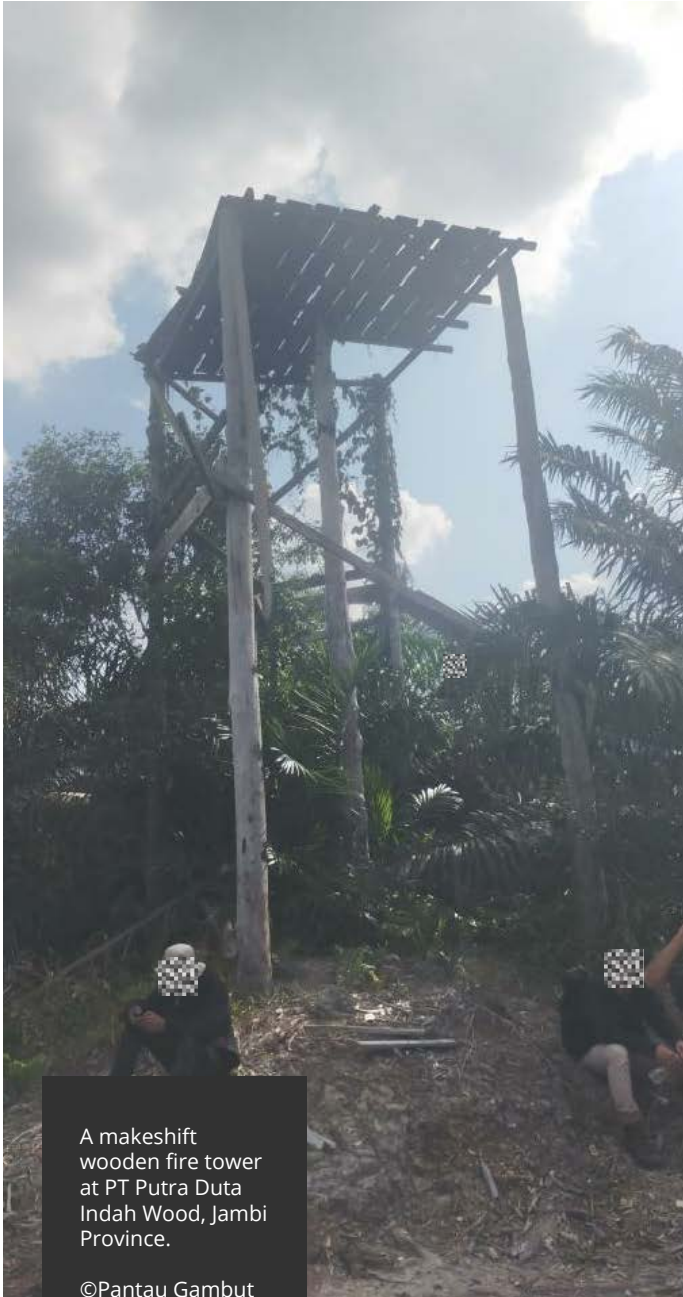
In general, the fire towers are in good condition. However, there is one fire tower at PT Putra Duta Indah Wood that poses a fire prevention risk as it is made of wood. Although the specific material used for constructing fire towers is not regulated in detail in Minister of Agriculture

A makeshift wooden fire tower at PT Putra Duta Indah Wood, Jambi Province.
