Dread in Wetland Bed

Corporations, Government, and All Their
Peatland Restoration Empty Commitments.

2024

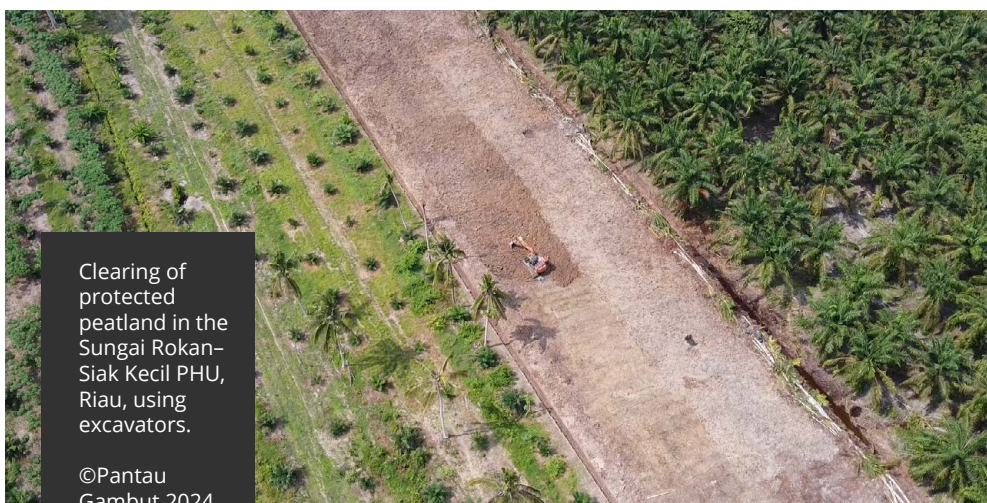
Pantau Gambut found that 57% of all protected peatland areas monitored for government restoration on burned area had been filled with dryland crop species such as oil palm. This clearly violates Article 26 of Government Regulation No. 57 of 2016 *jo*. Government Regulation No. 71 of 2014, which explicitly prohibits land clearing in protected peatland ecosystems.

(Left) Conversion of peatland function to oil palm in the Pulau Rupert PHU, Riau Province (Right) Burning of peatland in the Pulau Rupert PHU, Riau Province.

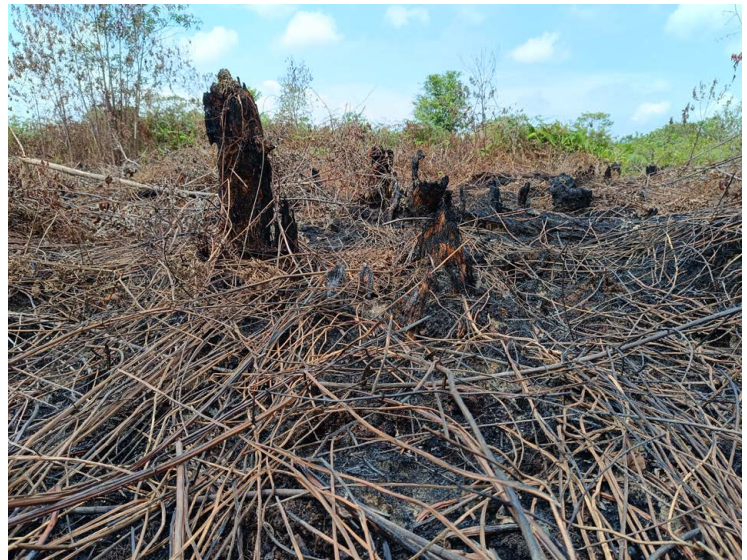
The proliferation of shrubs increases the potential for peatland fire spread.

In 41% of the samples from protected peatland areas that were previously burned, then abandoned and overtaken by shrub growth, restoration efforts should have been undertaken to convert these areas back into forests to reduce the risk of recurrent fires. Uncontrolled shrubbery serves as highly flammable material that can easily ignite and spread fires rapidly, especially when the vegetation is dry and has low moisture content.¹⁰
